CESSNA CARAVAN MODEL 208

Windshield Anti-Ice

Windshield Anti-Ice Panel

Overhaul / Exchange

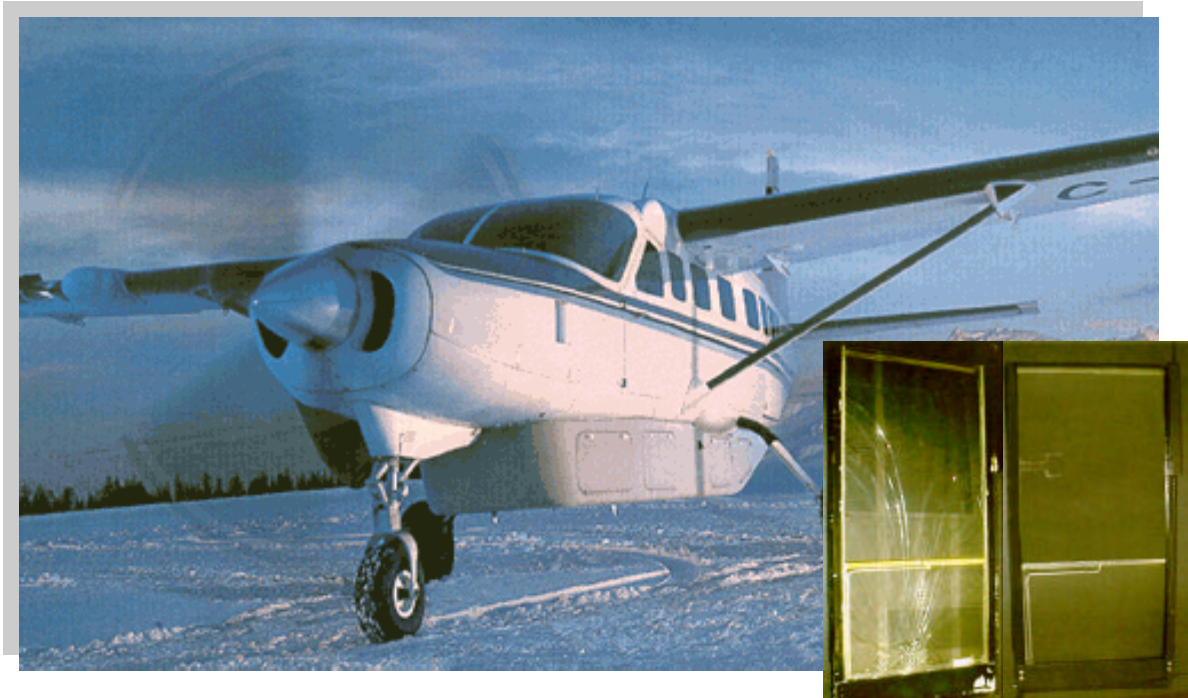
Before

After

Anti-Ice panels may become unserviceable due to wire heating element burnout and breakage, delamination, and glass ply breakage.

GKN Aerospace Transparency Systems offers comprehensive overhaul which replaces the damaged glass laminate and restores the panel to an “as new” condition.
